# Manhole Inspection Summary

Manhole # S33II\_024MH

Insp Date: **3/30/07 11:34 AM**

**Location** Address: **22 LANVALE ST**

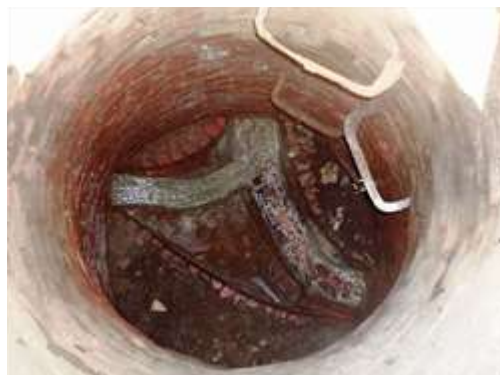
Top View

Corroded and missing steps. Corbel infiltration. Evidence of surcharge - Bench debris.

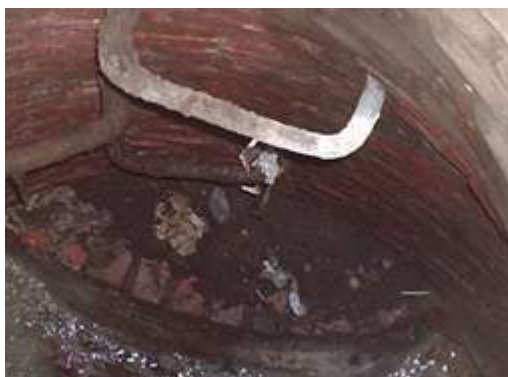
Defect

Evidence of surcharge - Bench debris.

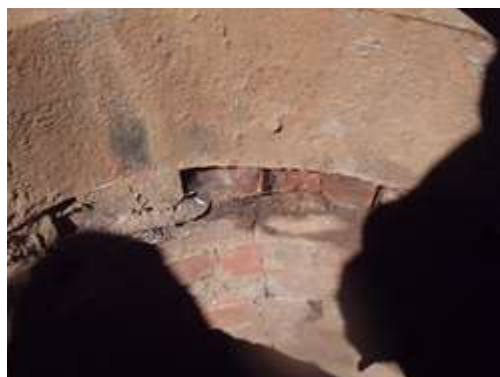
Defect

Adjustment deterioration, loose brick and infiltration.

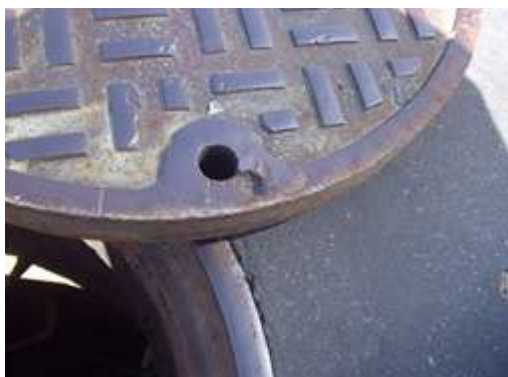
Defect

Worn cover.

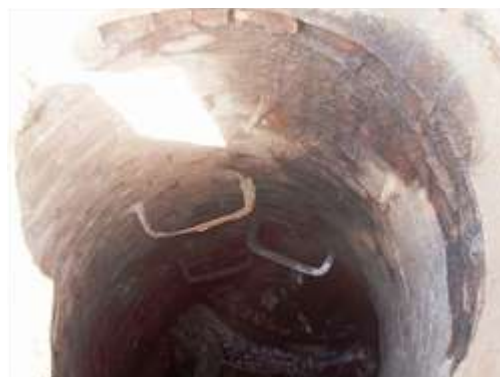
Defect

Frame leaks. Adjustment deterioration, loose brick and infiltration. Corbel deterioration and infiltration. Barrel

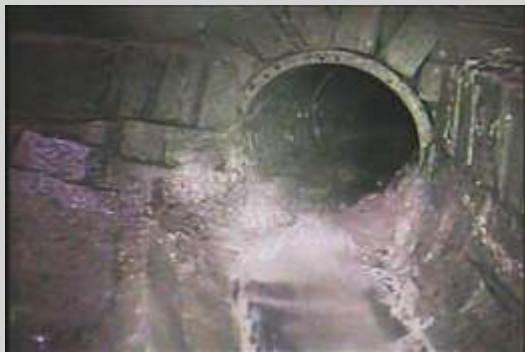
### 10 in. Circular Gravity Sewer Pipe Out @ 12 O'Clock

Channel deterioration.

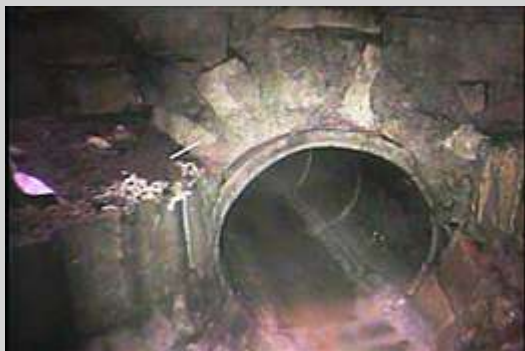
### 8 in. Circular Gravity Sewer Pipe In @ 3 O'Clock

Barrel deterioration and infiltration.
